Environmental Assessment, Remediation and Compliance Solutions

September 12, 2024

RE: 1107 Special Use Permit Information
160 East Main Road
Middletown, RI 02842
LSE Project No. 22093A10

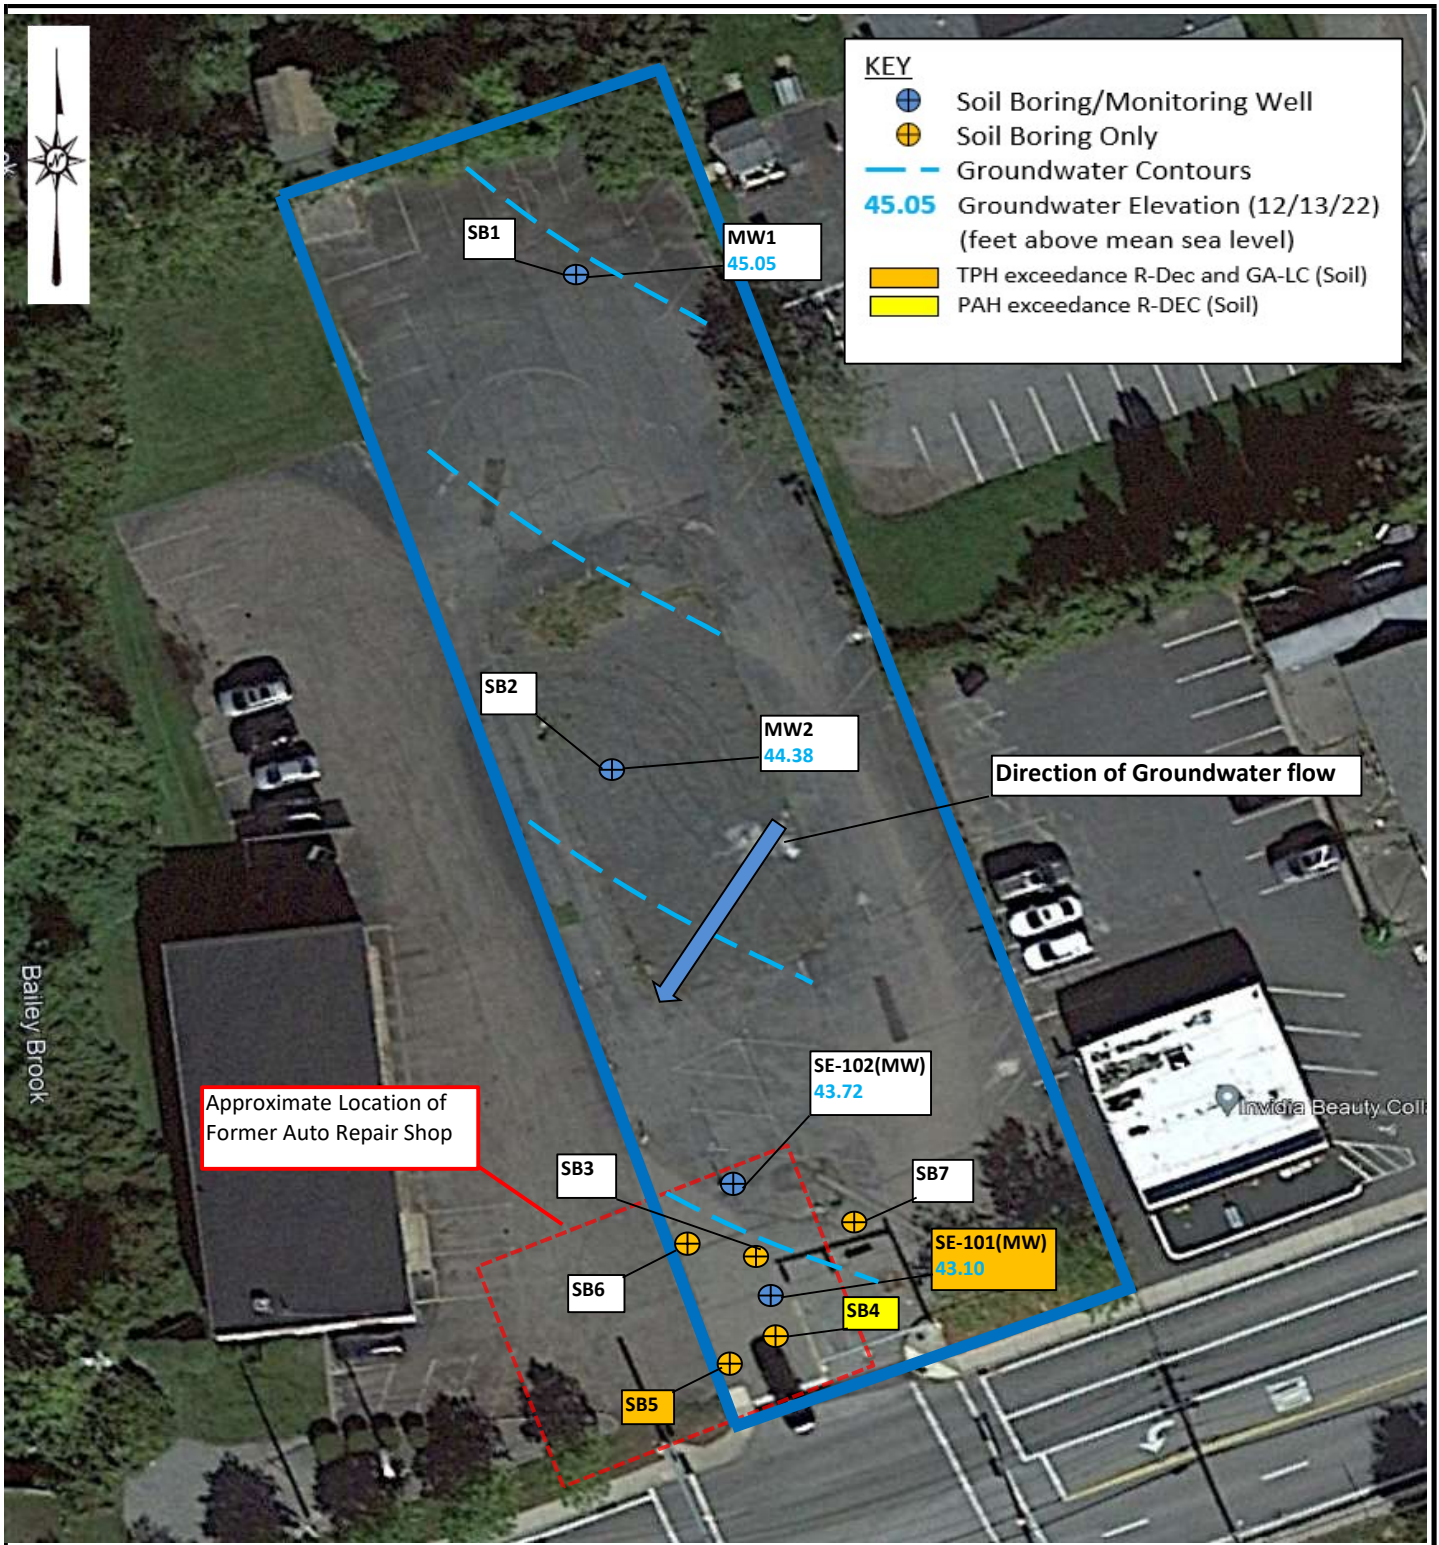
Figure No.	2	
Drawing Title:	Site Plan with Monitoring Well and Soil Boring Locations 160 East Main Road Middletown, RI	
Date Prepared:	1/16/23	Prepared By: BFH
Approximate Scale:	NTS	
LSE Proj. No.	22093A10	Lot Lines

The location of soil borings and monitoring wells is shown in attached Figure 2

- LSE surveyed the measuring point elevations of the four monitoring wells and groundwater was gauged on December 13, 2022. Groundwater contours shown on Figure 2 (attached) show groundwater flowing to the west and southwest toward Bailey Brook. This groundwater flow direction is consistent with local and regional topography, and the presence of nearby surface water bodies.

Based on LSE's findings, TPH was detected at a maximum concentration of 1,080 milligrams/kilogram (mg/kg) in boring SB5 at a depth of 4-5 ft-bg, exceeding the residential (R) DEC and GA-LC of 500 mg/kg but not the Industrial/Commercial (I/C) DEC (2,500 mg/kg). Both borings where TPH exceeded RIDEM soil standards were collected within the footprint of the former automotive garage. No other soil sample on the Site has been found to contain TPH at concentrations greater than applicable RIDEM soil standards. Two PAH analytes, were detected in boring SB4 (at the former automotive garage) at a depth of 5-6 ft-bg, at concentrations exceeding R-DEC, but not I/C-DEC. All detected metals were below applicable industrial/commercial and residential DEC. Although six weathered gasoline VOC constituents were detected in soil in boring SB5 at a depth of 4-5 ft-bg, none exceeded applicable RIDEM soil standards. Where present in soil, COC are located above the saturated zone and therefore do not pose a threat of impact to groundwater quality. No VOCs were detected in groundwater at any monitoring wells.

Until such time that RIDOT implements response actions relative to the TPH and PAH soil impacts at the southern end of the Property, LSE recommends that the bituminous pavement located at the RIDOT parcel near the current and future entrance to the Property remain paved as shown in the proposed development design.
