MAIDFORD RIVER

Watershed Assessment & BMP Design

JUNE 2015

Prepared by
FUSS & O'NEILL

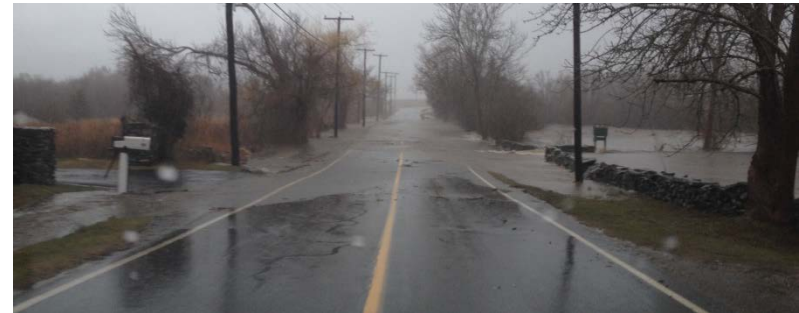
Roadway flooding is an ongoing problem in portions of the Maidford River watershed.

Flooding is also a major problem in these watersheds. Public roads crossing both streams routinely flood several times a year. This flooding impacts public safety by limiting access on public roads and causes property damage.

Flooding in the Maidford River watershed is a long-standing problem, with several road crossings flooding numerous times per year (Figure 4-1). Flooding not only damages private property, but also creates a public safety problem, limiting access for first responders and making travel unsafe for vehicles and also damages private property. Anticipated changes in precipitation frequency and intensity are expected to exacerbate flooding in Rhode Island (RI Sea Grant, 2014).

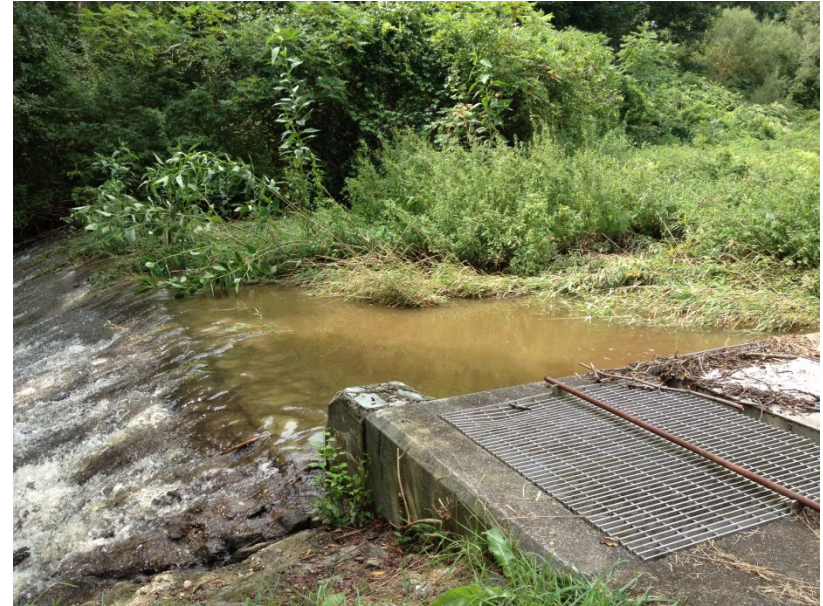
Turbid Water in Maidford River Adjacent to Newport Water Diversion

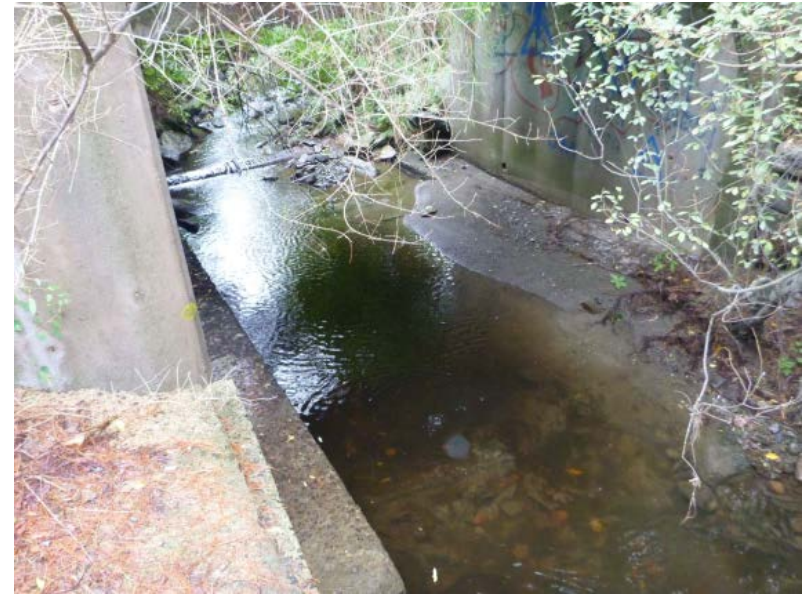
Visible turbidity in Maidford River at Reservoir Road (RIDEM, 2014)

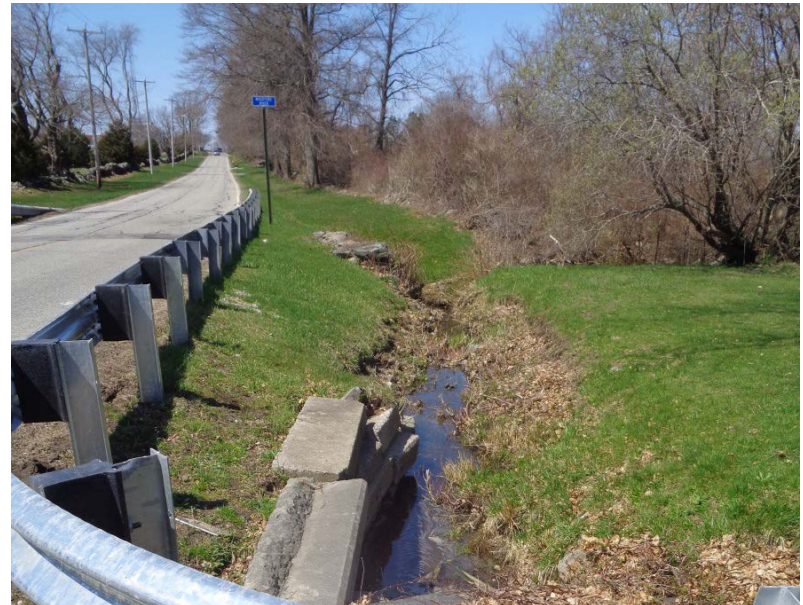
Lack of Riparian Buffer near Wyatt Road

However, pollutant loading is only part of the story – transport of pollutants from their source to the waterbody, along with pollutant generation, determined the water quality of streams and ponds. Impervious areas and soils with limited infiltration capacity (Figure 3-8), which do not allow for infiltration and storage of rainfall, lead to greater runoff generation and potentially greater runoff velocities, which increase the erosive power of runoff as it travels over the land surface. Vegetative cover on the land surface both slows and absorbs runoff, and vegetative buffers near streams can both trap sediment and pollutants and help to maintain stable stream banks.

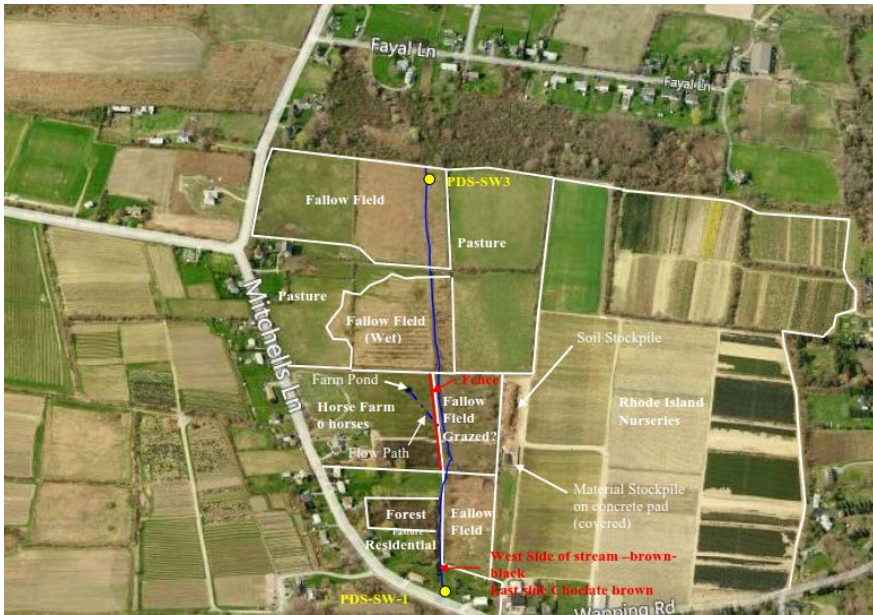
RIDEM Field Observations of Headwaters of Paradise Brook Note the area of fallow fields directly adjacent to stream.

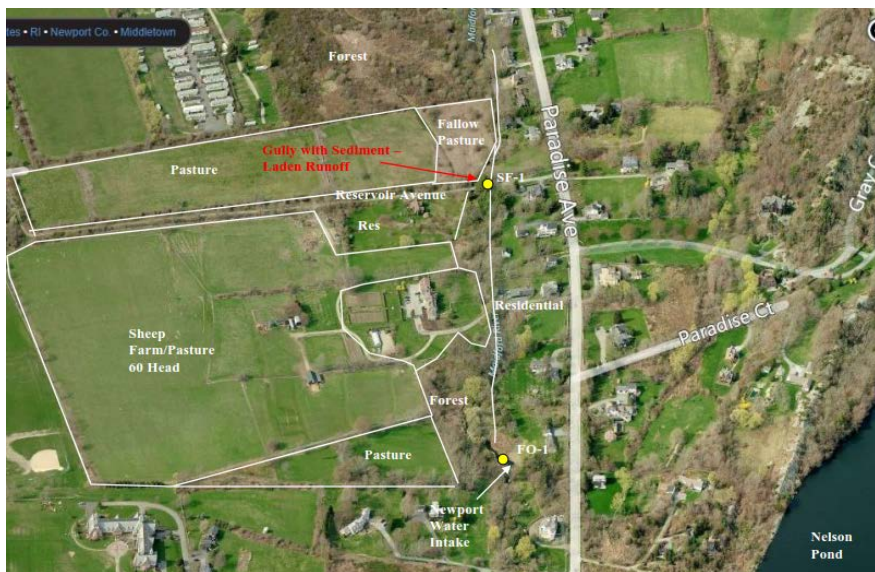
RIDEM Field Observations at Mouth of Maidford River Notation of heavy sediment load near Station MDF-SF-1.

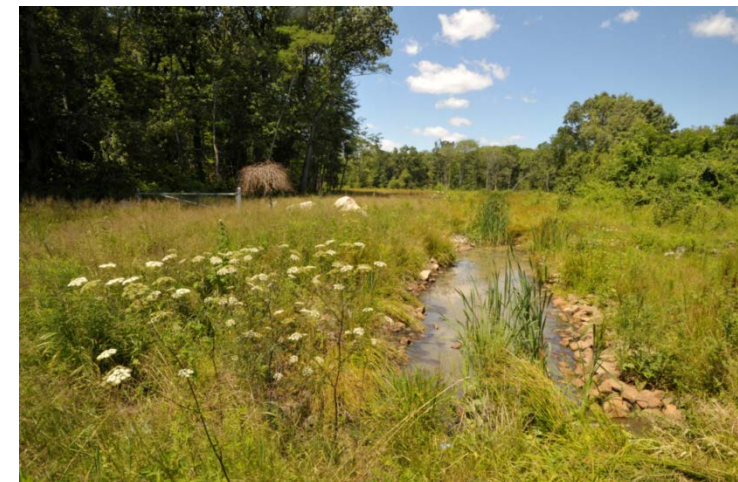
Completed Pocasset River Floodplain Restoration Project, Cranston, RI

Floodplain restoration projects are recommended as the most effective type of flood control BMP for this watershed. This type of restoration project consists of creating a floodplain “bench” adjacent to the stream channel. This bench creates additional volume to temporarily store water below the downstream road crossing. Bioengineering techniques are used to stabilize the streambank thereby improving habitat value and providing some natural filtration and vegetative uptake of runoff that drains across these areas. As a result, floodplain restoration can improve water quality from agricultural lands that drain directly to a restoration site.

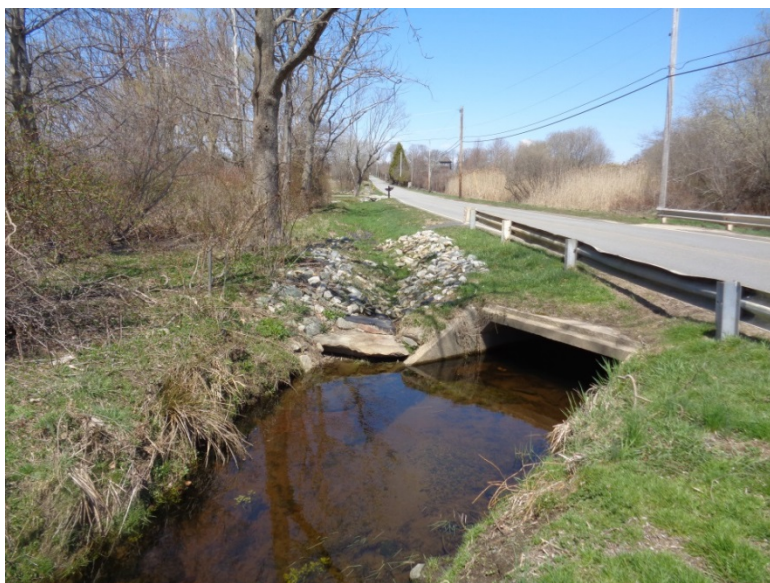
Berkeley Avenue Maidford River Crossing

- **Repair Stream Bank Erosion:** The streambank just upstream of Berkeley Avenue is eroding. This erosion adds to the sediment load to the stream. Stream bank erosion should also be assessed on private property, especially where flood plain restoration projects are being proposed.
- **Homeowner Lawn Care Education:** Education for local home owners to use soil testing and lawn care management practices to avoid over application of fertilizers, encourage the planting of buffers near streams, and properly dispose of lawn clippings.
- **OWTS Maintenance:** Proper care of onsite wastewater treatment systems, including routine inspection and pump out, is important to keep OWTS properly functioning.

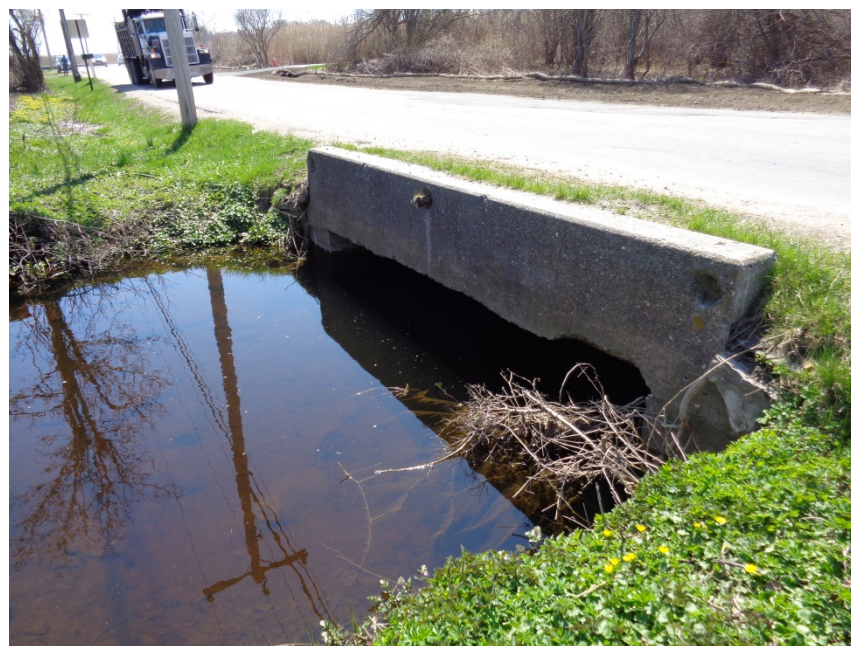
Paradise Avenue Maidford River Crossing

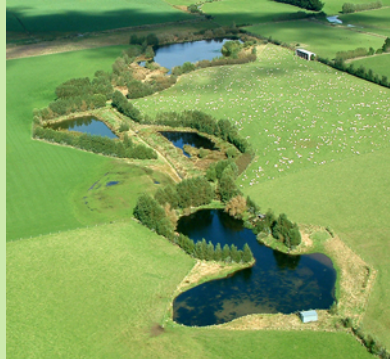
Practice	Benefits
<p>Constructed Wetland</p>

<ul style="list-style-type: none"> • For treatment of wastewater and contaminated runoff from agricultural processing, livestock, and aquaculture facilities, or • For improving the quality of storm water runoff or other water flows lacking specific water quality discharge criteria. <p>https://www.nrcs.usda.gov/wps/portal/nrcs/detail/soils/edu/?cid=nrcs144p2_027203</p>

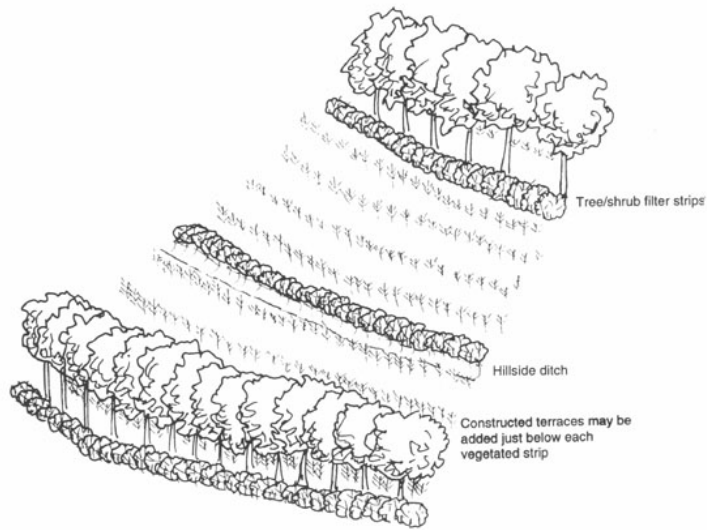
Sketch of a typical filter strip planting (Source: <http://www.nrcs.usda.gov>)

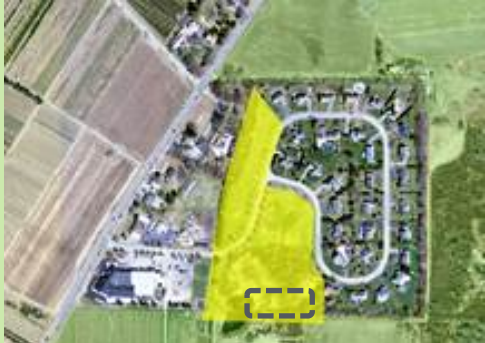
BMP Name and Description	Highlights	Expected Benefits
Group A - Retrofit Existing Detention Basins		
<p>A1: Bioretention for runoff from East Meadows neighborhood</p>

<ul style="list-style-type: none"> • Construct bioretention system in existing field/open space upstream of the existing detention pond where runoff could be diverted to bioretention system before draining into detention basin • Bioretention system would be underdrained because of poor soils • Alternative is to consider a Wet Vegetated Treatment System 	<ul style="list-style-type: none"> • Phosphorous, nitrogen, and bacteria load reduction • Some attenuation of peak flows by providing additional detention in bioretention cells • Maximizes use of existing infrastructure
<p>A2: Retrofit Hoogendoorn Nurseries Detention Basins along Berkeley Avenue</p>

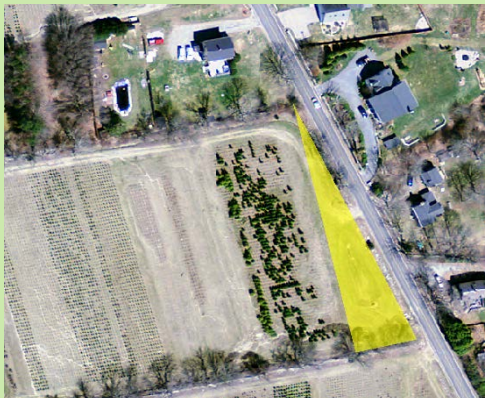
<ul style="list-style-type: none"> • Retrofit existing detention basins that serve a large portion of the nursery grounds • The detention basins had evidence of routine overtopping into the Berkeley Avenue System and likely short circuits, providing little existing treatment • Retrofit concept is to connect the 2 existing basins into one large system with a baffle down the middle to lengthen the flow path and maximize sediment removal • May qualify for NRCS EQIP grant funding 	<ul style="list-style-type: none"> • Reduction of peak flows by making the twin detention basins more efficient • More efficient sediment removal by implementing improvements to minimize short circuiting • Maximizes use of existing infrastructure

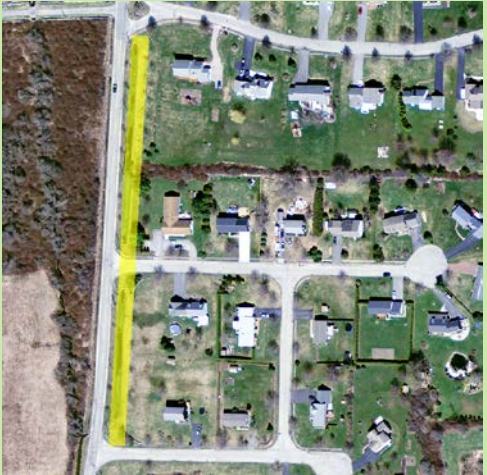
<ul style="list-style-type: none"> • Retrofit concept is to convert the existing grass channel to a Wet Vegetated Treatment System • Multiple cells in series will maximize treatment in a linear project area • The system will require a liner to prevent groundwater infiltration into the system and maximize capacity to manage stormwater • This retrofit will not reduce the system’s existing storage capacity as the new wet vegetated treatment system will be constructed below the existing detention basin. 	<ul style="list-style-type: none"> • Phosphorous, nitrogen, and bacteria load reduction • No loss of existing detention capacity • Improved habitat value • Maximizes use of existing infrastructure
Group B - Retrofit Existing Roadside Swales		
<p> B1: Wyatt Road B2: Paradise Avenue (north of Green End Avenue) B3: Paradise Avenue (south of Green End Avenue) B4: Green End Avenue B5: Third Beach Road B6: Prospect Avenue B7: Paradise Avenue near Nelson Pond </p>

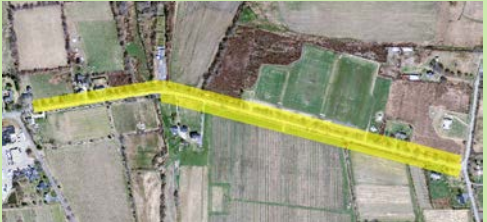
<p>Example - Wyatt Road Swale</p>	<ul style="list-style-type: none"> • Retrofit existing roadside swales to include check dams, emergent plants, and an underdrain system • Bioretention system would be underdrained because of poor soils • Cost is lower compared to new structural BMPs • BMPs can be implemented within the roadway easement • Additional maintenance required since road runoff has high sediment loads 	<ul style="list-style-type: none"> • Phosphorous, nitrogen and bacteria load reduction • Some limited reduction in peak flow for smaller storms that can be retained by check dam system in retrofitted swales • Maximizes use of existing infrastructure

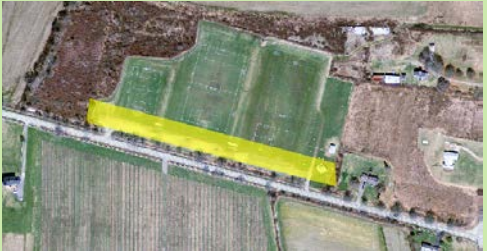
BMP Name and Description	Highlights	Expected Benefits
Group C – New Stormwater BMP		
<p>C1: Bioretention at Middletown Youth Soccer Fields and Parking Lots</p>

<ul style="list-style-type: none"> • Construct bioretention areas in between the parking area and the soccer fields upgradient of existing catch basins • Overflow will be directed to existing storm drainage system • Good demonstration value at public soccer fields • Maintenance can be conducted as a part of routine field maintenance 	<ul style="list-style-type: none"> • Phosphorous, nitrogen and bacteria load reduction • Peak flow reduction by providing additional storage in bioretention areas • Public demonstration value
<p>C2: Remove pavement in shoulder on Turner Road and replace with linear bioretention</p>

Group C – New Stormwater BMP					
C1: Bioretention at Middletown Youth Soccer Fields and Parking Lots	2	2	2	1	16
C2: Remove pavement in shoulder on Turner Road and replace with linear bioretention	2	1	3	2	20
C3: Bioretention on public land adjacent to the Maidford River on Green End Avenue	1	2	3	2	18
C4: Tree boxes between sidewalk and curb on Windham Avenue, Beagle and Tally Ho, Trout Drive, Lighthouse View Drive, River Runs Road/Maidford River Road	1	2	3	1	16
C5: Linear bioretention for parking lot runoff at Paradise Valley Park	2	2	3	1	19
C6: Divert Prospect Avenue storm drainage into bioretention at corner of Paradise Valley Park prior to discharge into Maidford River	1	2	3	2	18

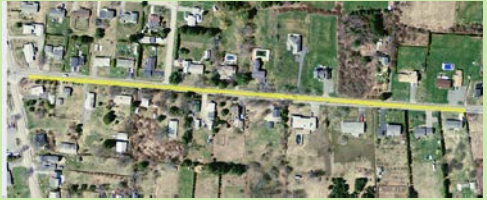
<ul style="list-style-type: none"> • The shoulder of Turner Road between Green End Avenue and Hoogendoorn Nurseries is paved and contains residential mail boxes. • Proposed concept involves pavement removal. This area could either be restored to grass or replaced with linear bioretention, which would treat roadway and driveway runoff. • The homeowners would benefit with an aesthetic improvement to their curb appeal. 	<ul style="list-style-type: none"> • Phosphorous, nitrogen and bacteria load reduction • Peak flow reduction

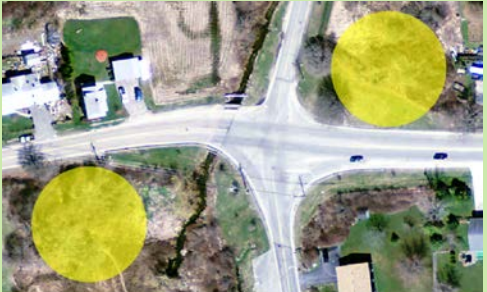
<p>C3: Bioretention on public land adjacent to the Maidford River along Green End Avenue</p>

<ul style="list-style-type: none"> • Divert stormwater collected from upstream areas into bioretention areas (one on the southwest corner and one on the northeast corner) • Opportunity to treat stormwater collected in privately-owned developed areas within public lands prior to discharge to the Maidford River. This includes a condominium complex to the west and a subdivision to the east. 	<ul style="list-style-type: none"> • Phosphorous, nitrogen and bacteria load reduction • Peak flow reduction

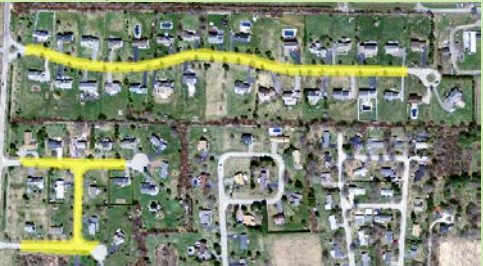
<p>Windham Avenue, Tally Ho court, Beagle Drive Tree Box Locations</p>	<ul style="list-style-type: none"> Proposed for neighborhoods that have a sidewalk on at least on side of the road Avoids projects on residential “front lawns” by using the tree belt will be more acceptable to homeowners Provides public shade trees that have additional benefits. Low cost to install and maintain Provides similar benefits to bioretention areas Overflow can connect directly to existing drainage system 	<ul style="list-style-type: none"> Increase public awareness Acceptable retrofit within single-family neighborhoods Phosphorous, nitrogen and bacteria load reduction Peak flow reduction

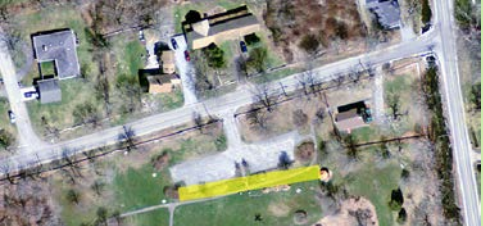
<p>C5: Linear bioretention for parking lot runoff at Paradise Valley Park</p>

<ul style="list-style-type: none"> Primarily for demonstration value Parking lot is close to the Maidford River Small parking lot so low cost bioretention area 	<ul style="list-style-type: none"> Phosphorous, nitrogen and bacteria load reduction Peak flow reduction Public demonstration value
<p>C6: Divert Prospect Avenue storm drainage into bioretention at corner of Paradise Valley Park prior to discharge into Maidford River</p>

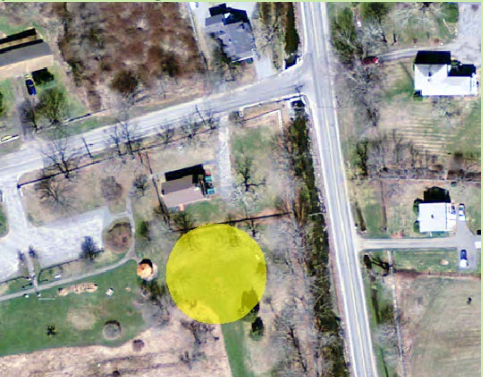
<ul style="list-style-type: none"> Divert stormwater collected from upstream areas into bioretention area Opportunity to treat stormwater collected in privately-owned areas within public lands prior to discharge to the Maidford River 	<ul style="list-style-type: none"> Phosphorous, nitrogen and bacteria load reduction Peak flow reduction
