## **Natural Resource Services, Inc.**

RE: Site Inspection for Freshwater Wetlands  
AM 107SE, Parcel 403; Valley Road  
Middletown, Rhode Island

**Site Inspection Sketch**  
**Valley Rd**  
**A.P. 107SE, Lot 403**  
 Middletown, RI

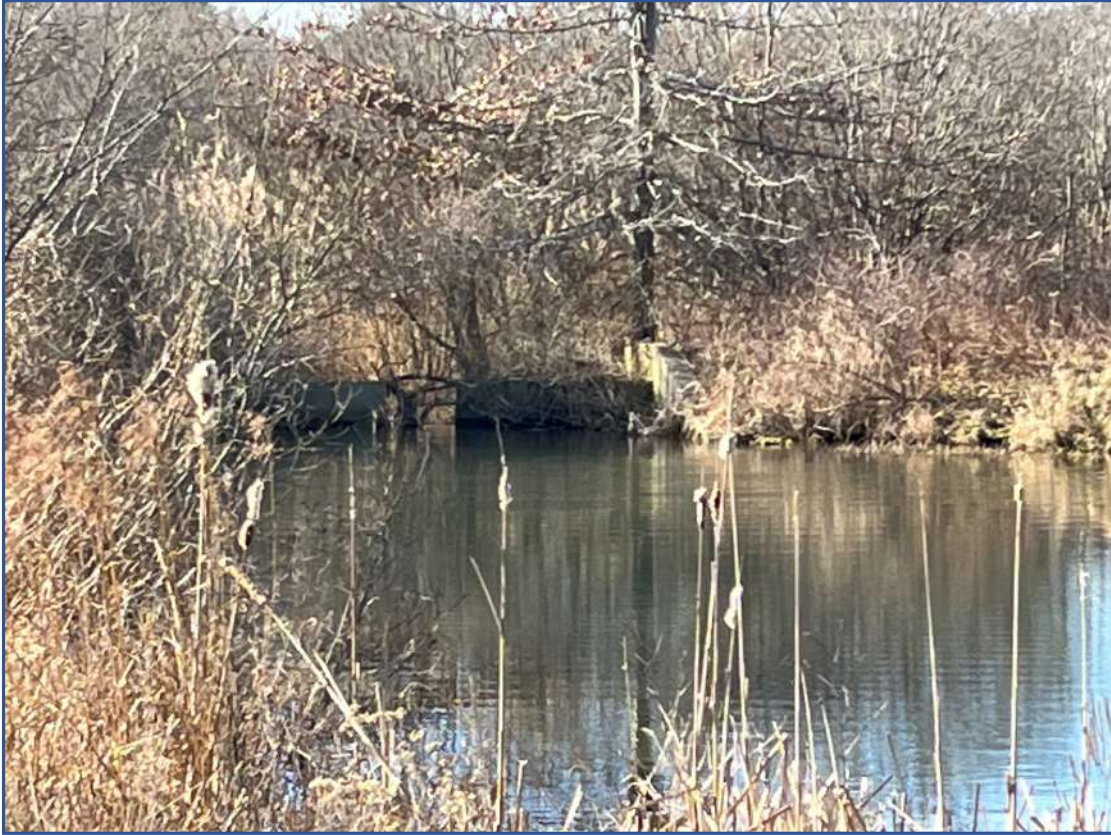
*Concrete spillway at the southwest corner of the detention pond*

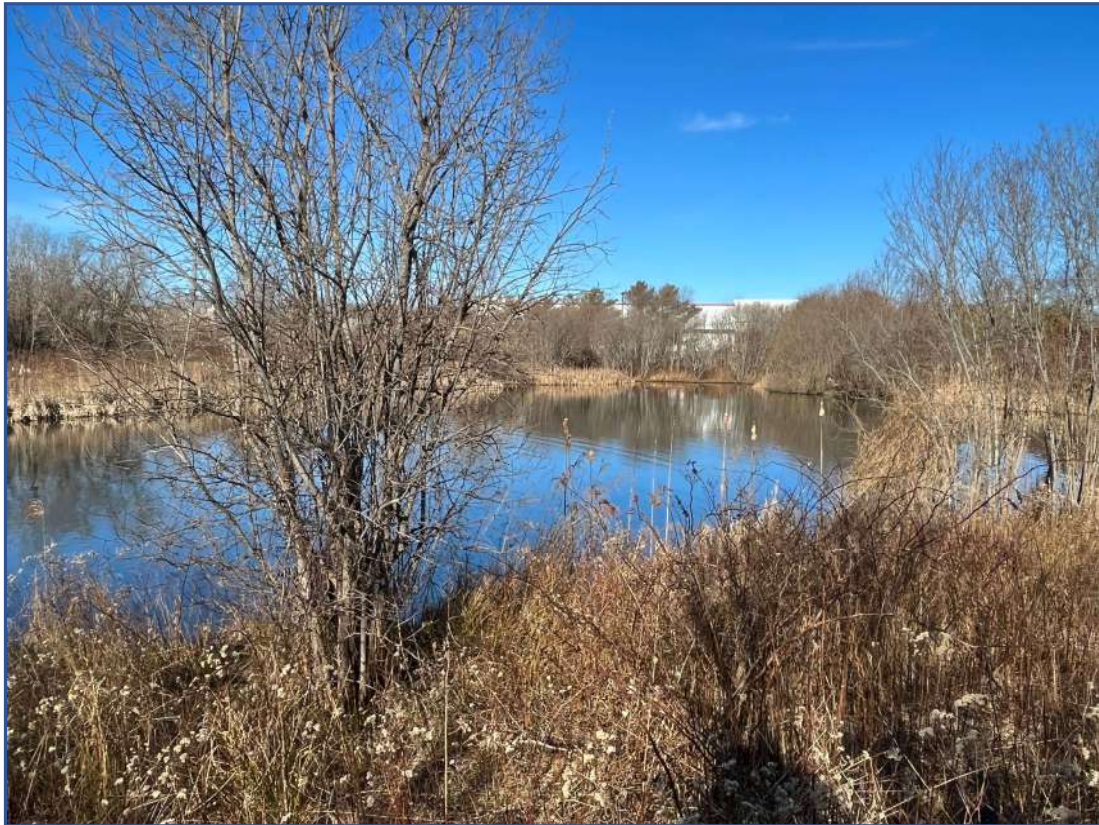
The adjacent access driveway services a commercial plaza with an entrance on Main Road. The stormwater from the pavement of this road enters a catch basin and is discharged to a large detention pond. This stormwater management structure has naturalized over several decades due to lack of maintenance along the perimeter. There is a concrete spillway at the southwest corner of the detention pond which discharges overflow into a swamp. One section of this detention pond occurs within approximately 125 feet of the subject property.

Therefore, the off-site detention basin is not regulated as a freshwater wetland.

*Looking North at the stormwater detention pond*

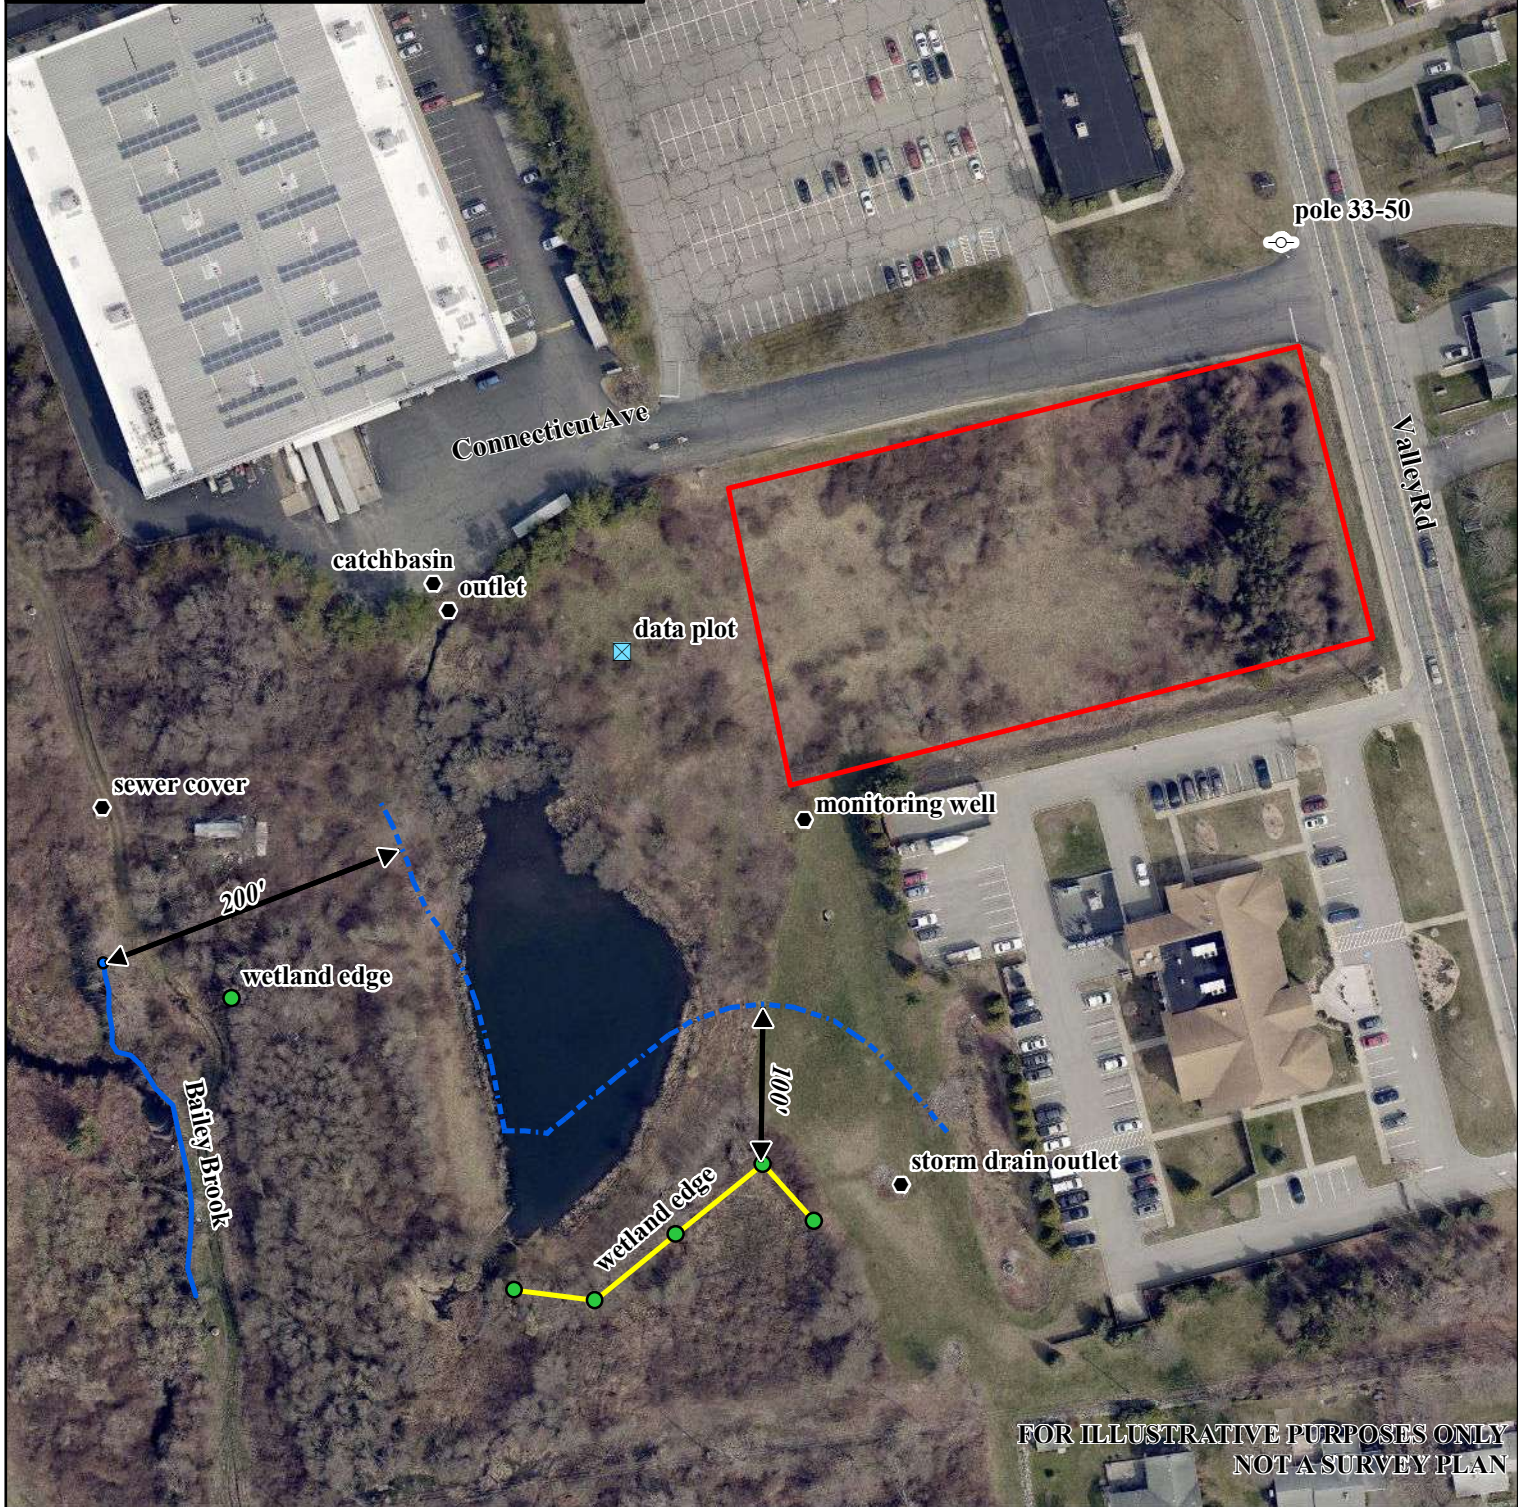
A freshwater wetland was identified at the southeast corner of the detention pond behind the Middletown Police Station. There is an area of wet meadow extending up to the mowed lawn in this location. The attached GIS graphic depicts the approximate limit of the wetland meadow in relation to the subject lot. The wetland regulations apply a 100 jurisdictional area (JA) to all freshwater wetlands. Any proposed land disturbing activities within the JA requires a permit from the DEM, Freshwater Wetlands Program. It is clear that the 100-foot JA applied to the wet meadow does not encroach onto the subject property.

In summary, there are no state regulated freshwater wetlands present on or immediately adjacent to the parcel 403. The stormwater detention pond located to the west of the lot is not regulated as a freshwater wetland pursuant to Section 3.5.1 of the regulations. The parcel does not fall within the 100-foot JA of the wet meadow located behind the police station or the 200-foot JA of Bailey’s Brook.
